INDOOR AIR QUALITY ASSESSMENT

**Chapin Elementary School
40 Meadow Street
Chicopee, Massachusetts**

Prepared by:
Massachusetts Department of Public Health
Bureau of Environmental Health Assessment
Emergency Response/Indoor Air Quality Program
August 2003

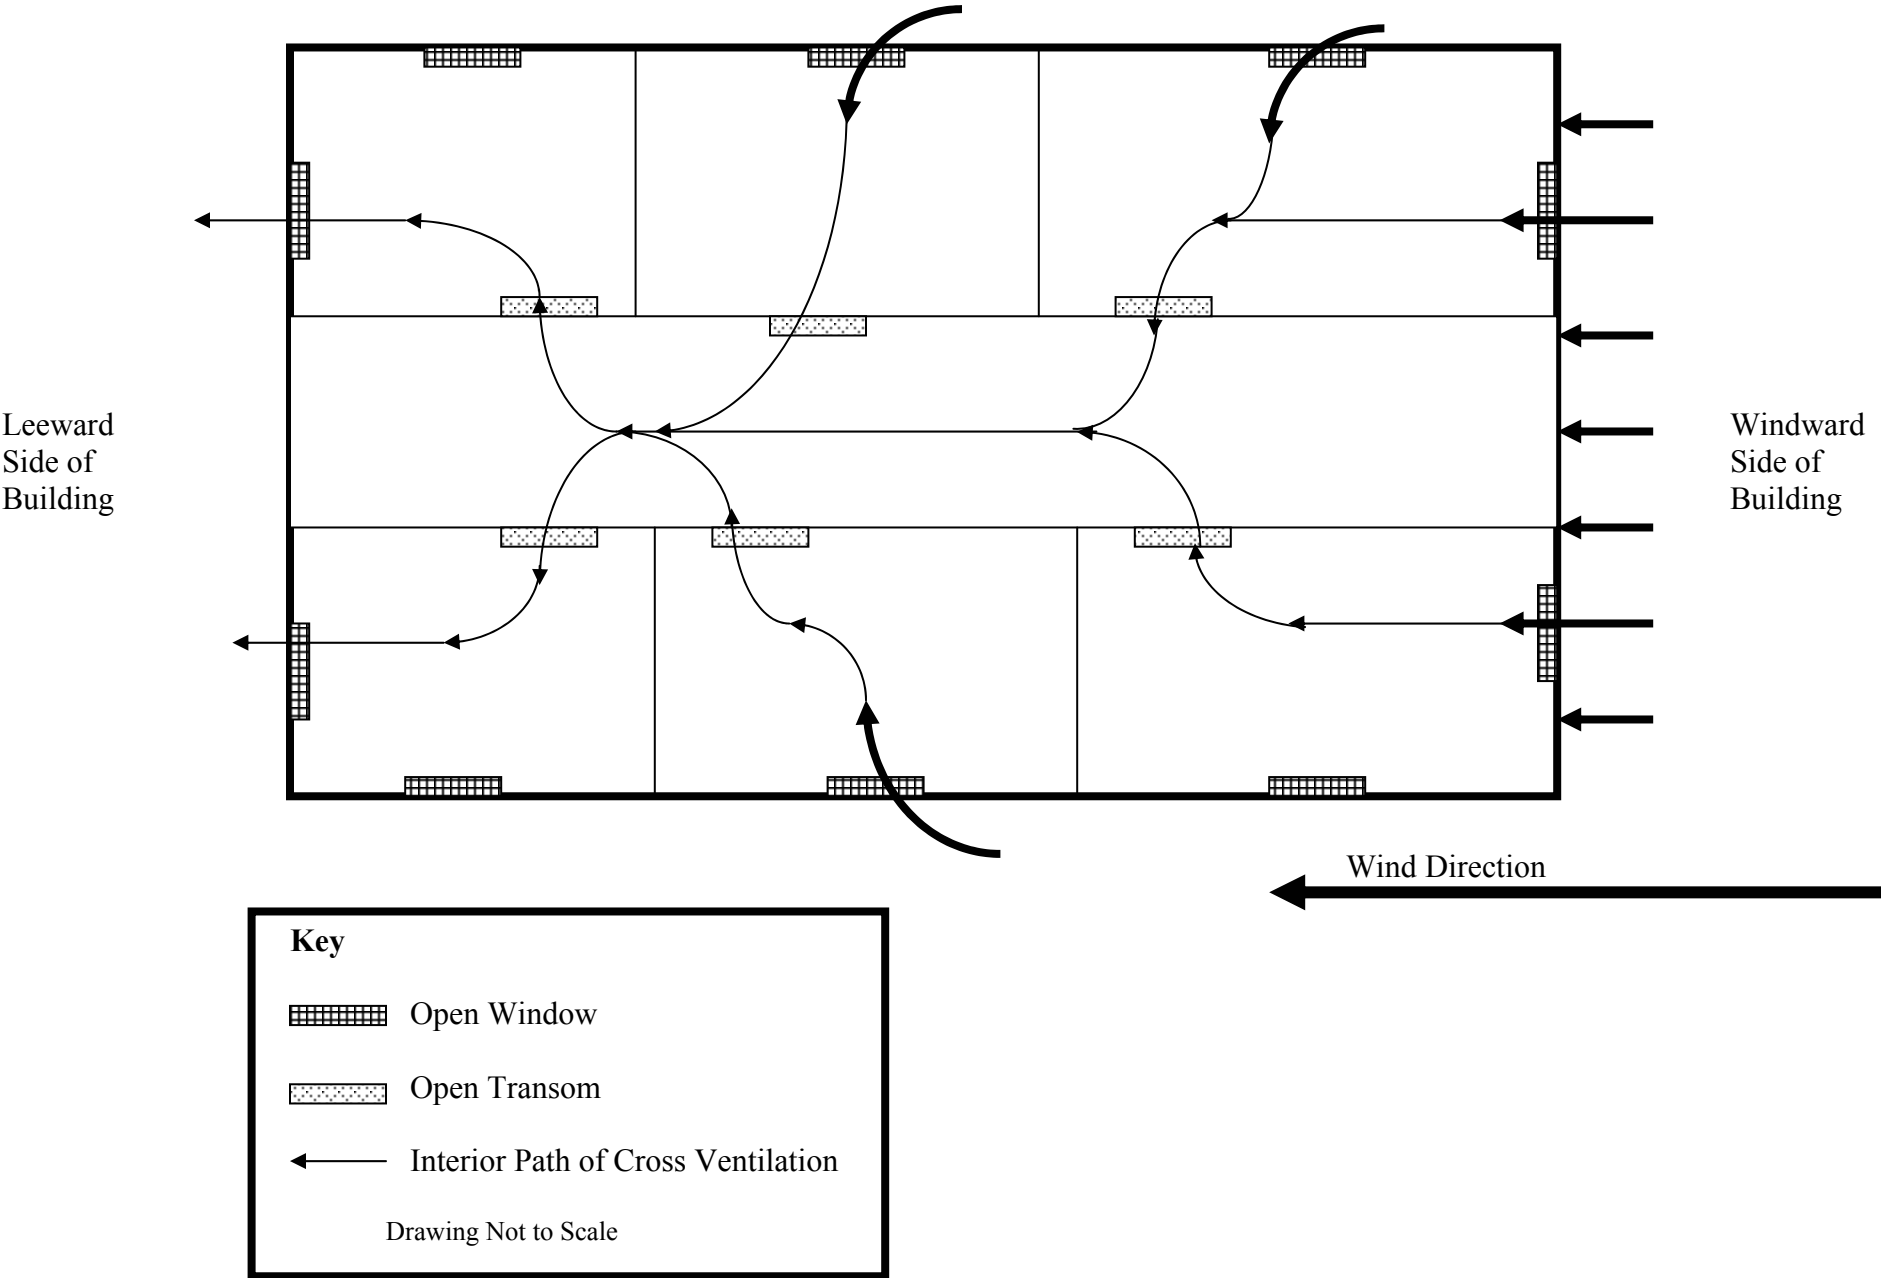
Figure 1

Cross Ventilation in a Building Using Open Windows and Transoms

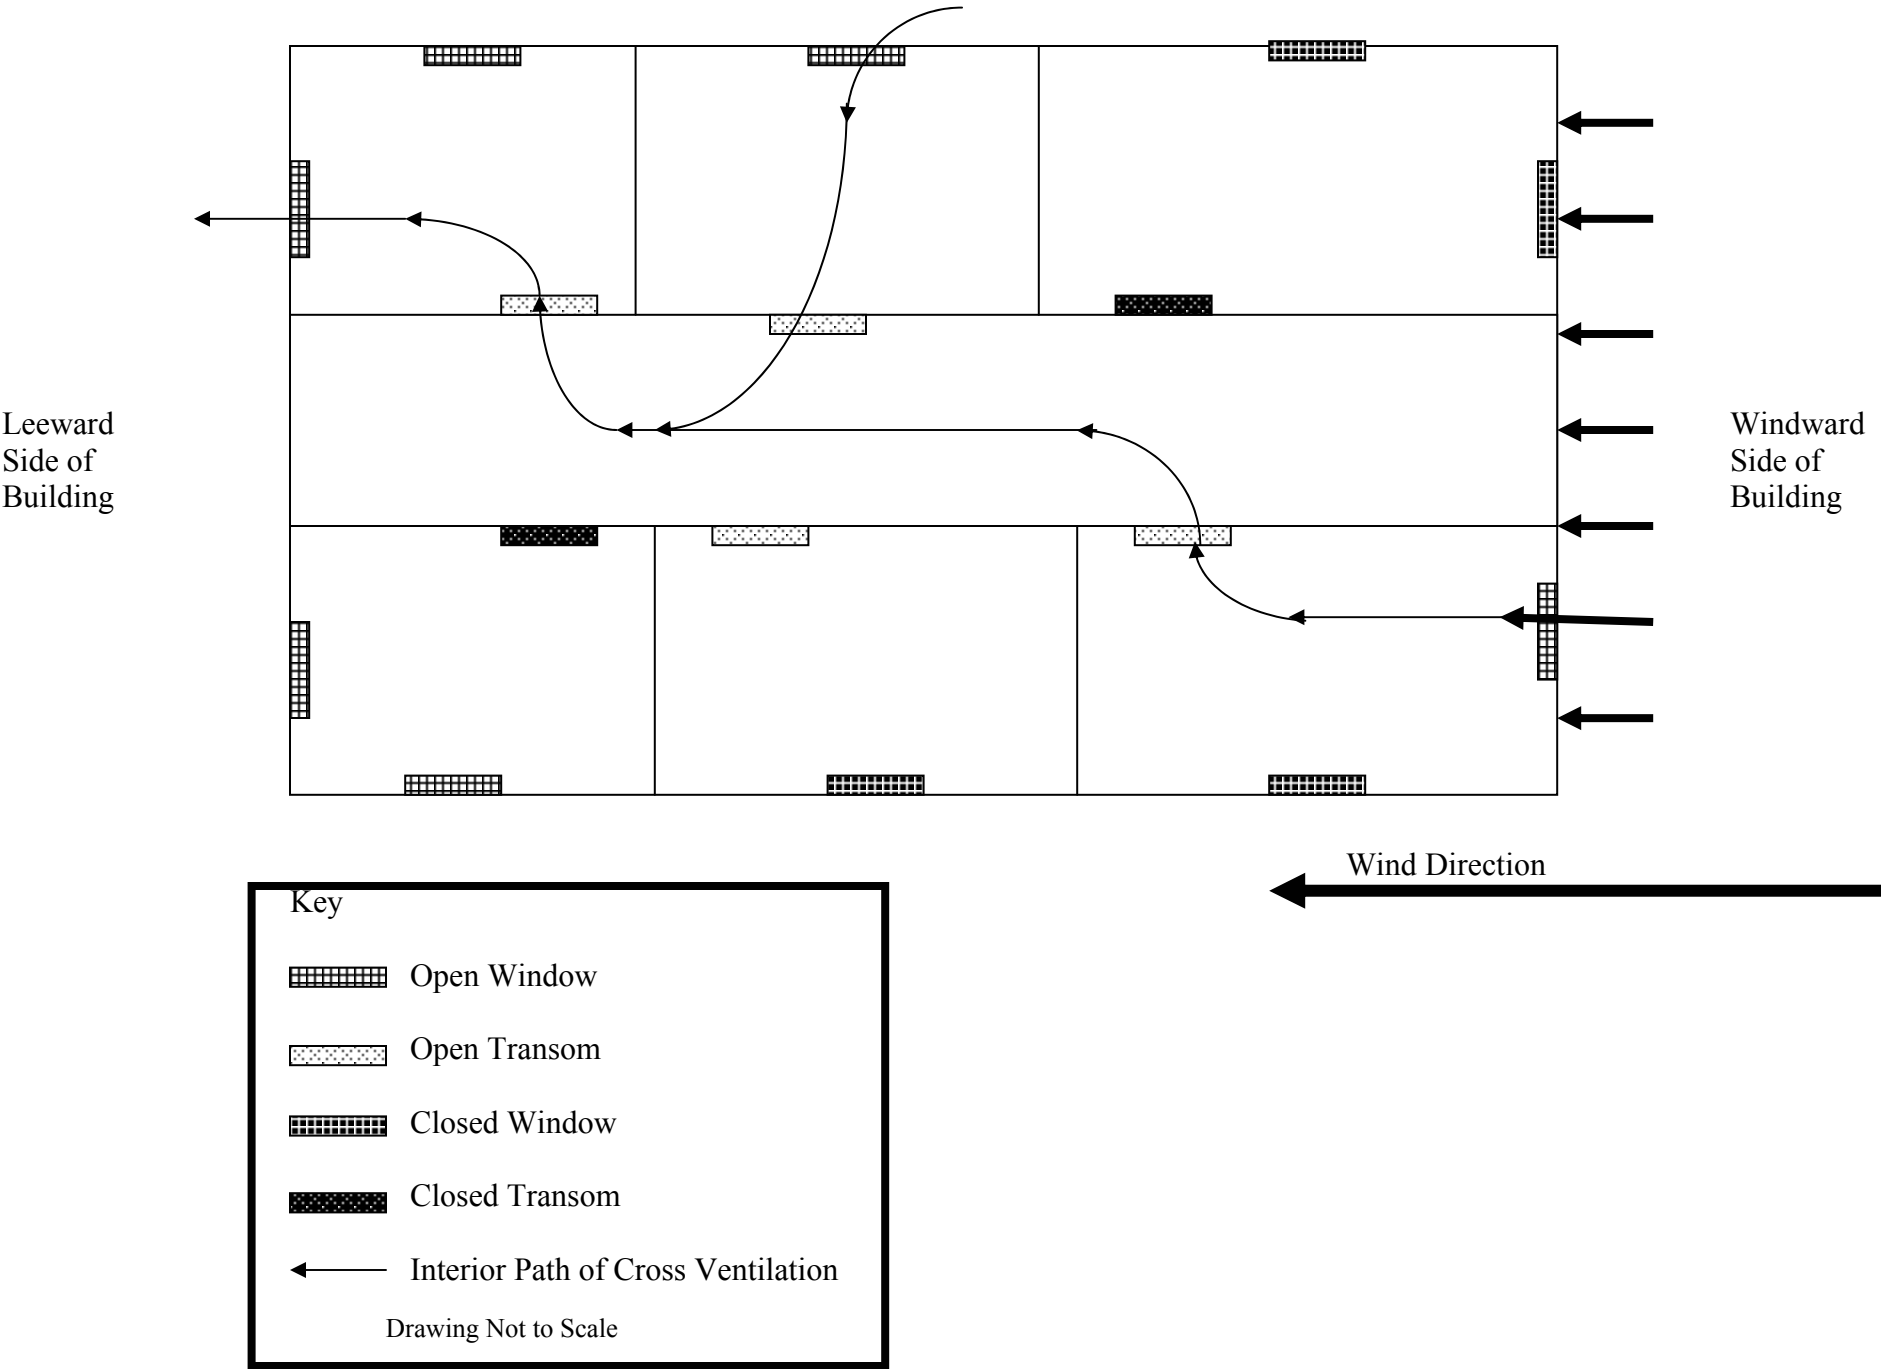
Figure 2

door while maintaining a pathway for airflow. This design allows for airflow to enter an open window, pass through a classroom, pass through the open transom, enter the hallway, pass through the opposing open classroom transom, into the opposing classroom and exit the building on the leeward side (opposite the windward side) (see Figure 1). With all windows and transoms open, airflow can be maintained in a building regardless of the direction of the wind. The system fails if the windows or transoms are closed (see Figure 2). A long pole with a hook was typically used to open the hoop latch that locks the transom closed in each classroom. Most transoms in the building were closed during the assessment, which can inhibit airflow in the summer.

Inhibition of Cross Ventilation in a Building with Several Windows and Transoms Closed

- 1) Use open windows and hallway doors to enhance airflow during warm weather. Be sure to close windows and doors at the end of the school day. To aid in the draw of fresh outdoor air in warm weather, use portable fans directing air out windows on the leeward side of the building. Fans positioned in this manner will serve to increase the draw of outdoor air across a floor without interfering with the natural, internal airflow pattern of the building. To aid cross ventilation, open hallway doors in areas with inoperable transoms.

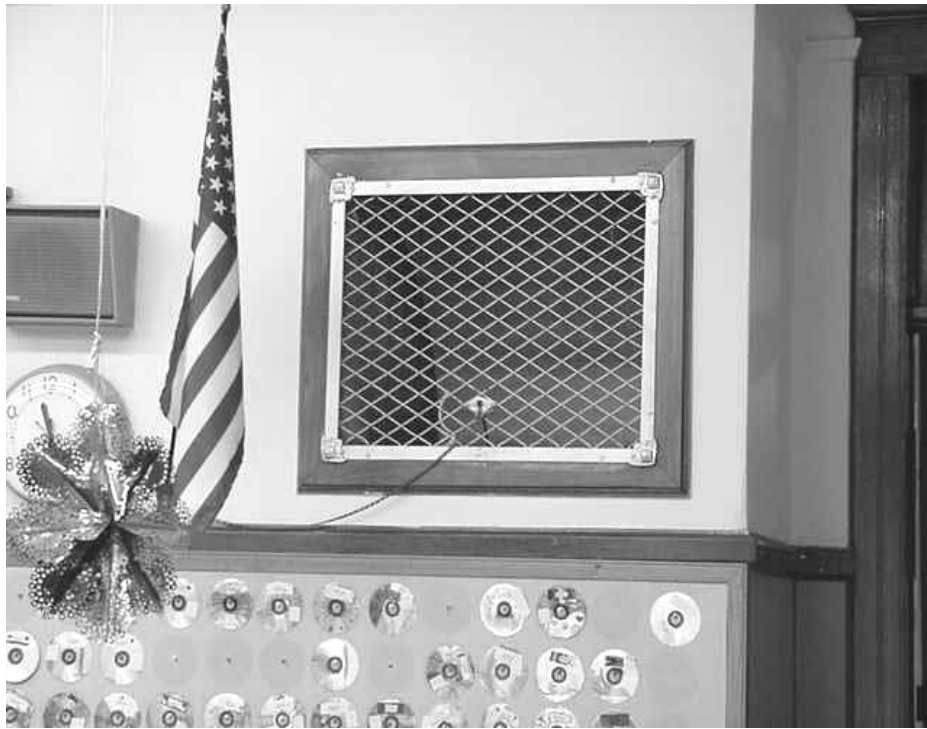
Picture 1

Grated Fresh Air Vent

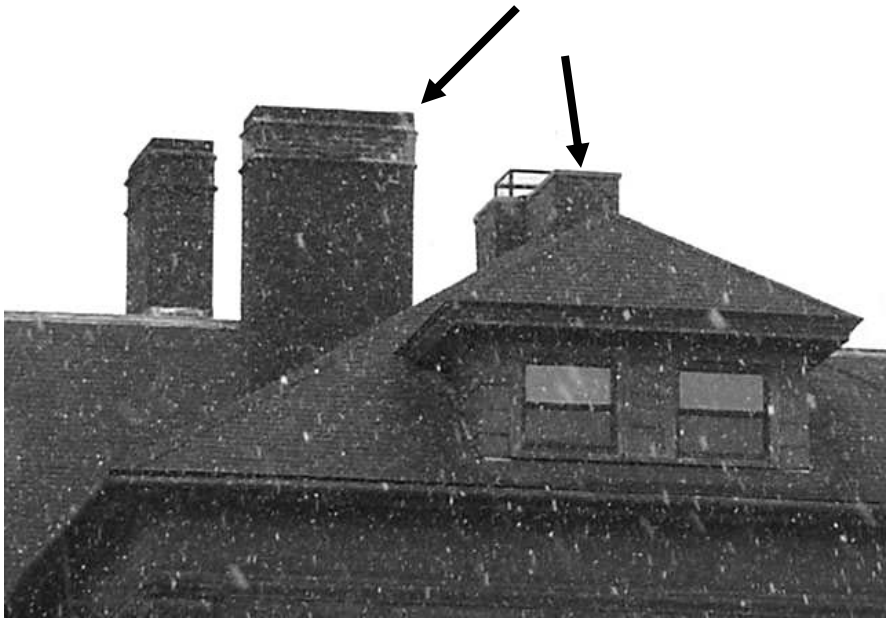
Picture 2

Rooftop Air Shaft Termini

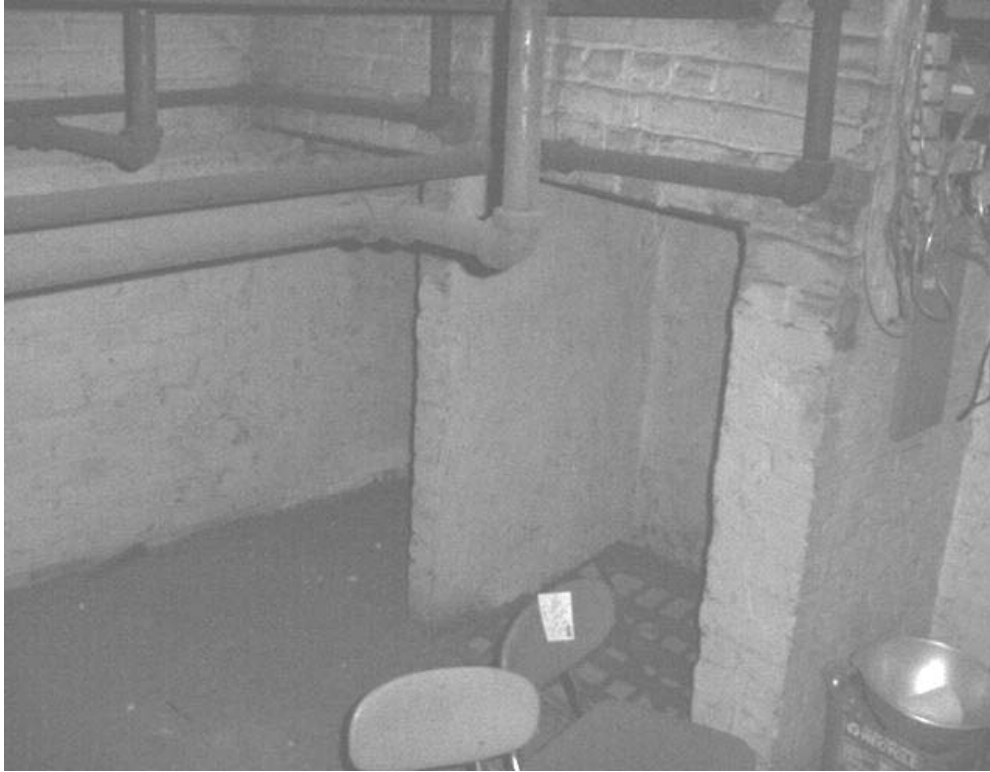
Picture 3

The building does not have a modern mechanical ventilation system, but originally used a gravity/natural ventilation system to provide airflow to most classrooms in combination with openable windows. Ventilation is provided by a series of louvered vents. Each classroom has an approximately 3' x 3' grated air vent on an interior wall near the ceiling (see Picture 1), which is connected by an airshaft to a chamber in the basement (the air mixing chamber). Inside each chamber is a heating element that was connected to the school boiler. These vents were originally designed with pull-chains connected to louvers, which adjust the airflow. A corresponding 3' x 3' vent exists in each room near the classroom doorways, which is connected to an exhaust ventilation shaft that runs from the roof to the basement. Four of these exhaust ventilation shafts open into the air-mixing chamber. Classrooms were constructed around these shafts to provide exhaust ventilation. Each of the ventilation shafts extends through the roof (see Picture 2) on either side of the school and terminate in a “hearth”-like opening in the air-mixing chamber (see Picture 3).

“Hearth”-Like Opening in the Air-Mixing Chamber

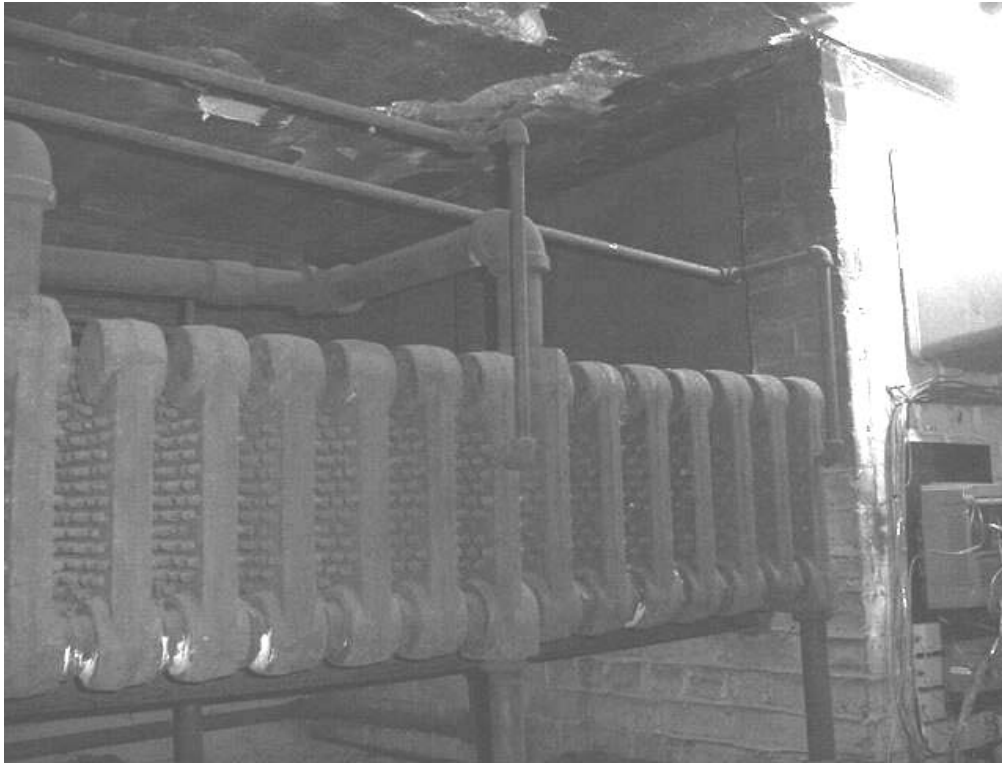
Picture 4

Air movement is provided by the stack effect. Located in the air-mixing chamber is a large heating element (see Picture 4). Heating elements were also installed in airshafts above classroom exhaust vents. The heating elements warm the air, which rises up the ventilation

Heating Element in Air Mixing Room

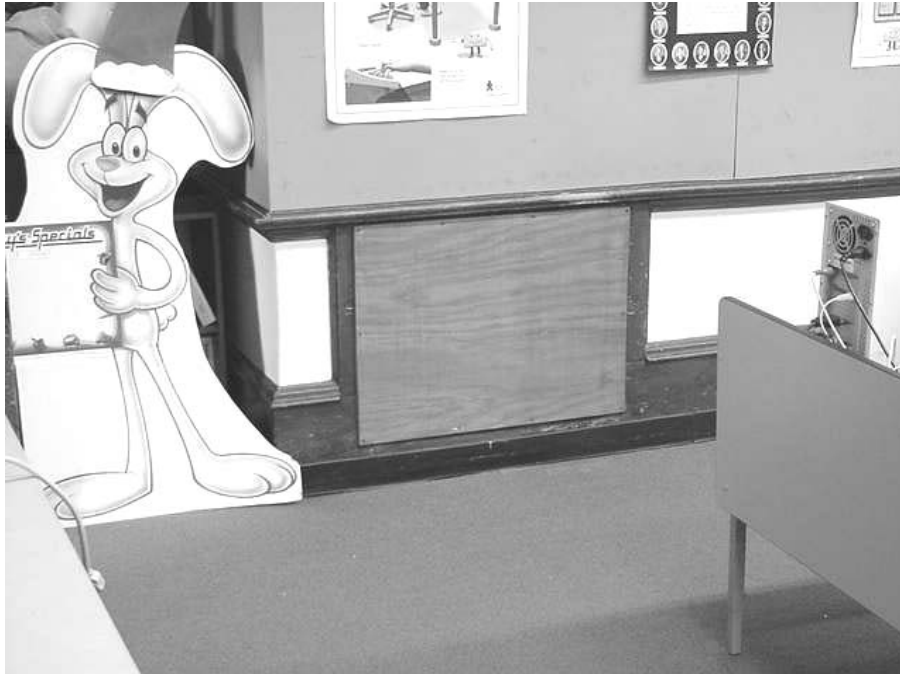
Picture 5

Different portions of the gravity ventilation system have been abandoned. Exhaust vents were sealed with plywood (see Picture 5). Heating elements in the air mixing rooms and within exhaust vents have also been disconnected. Lastly, the windows in the air mixing chambers were replaced with non-openable windows. The result of this abandonment disabled the ability of the gravity ventilation system to distribute fresh air into the CES. Currently, the sole source of fresh air in classrooms is the window system.

Exhaust Vent Sealed with Plywood

- 2) If original mechanical ventilation systems are not fully restored, ensure abandoned exhaust and supply vents are properly sealed in classrooms, the basement and on the roof to eliminate pathways for movement of odors and particulates into occupied areas.

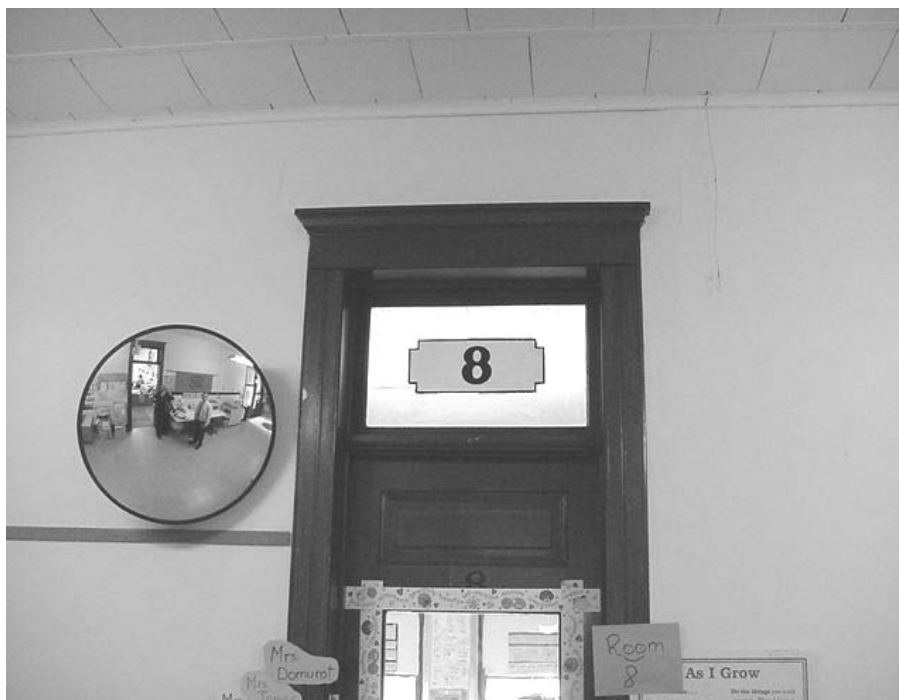
Picture 6

Transom

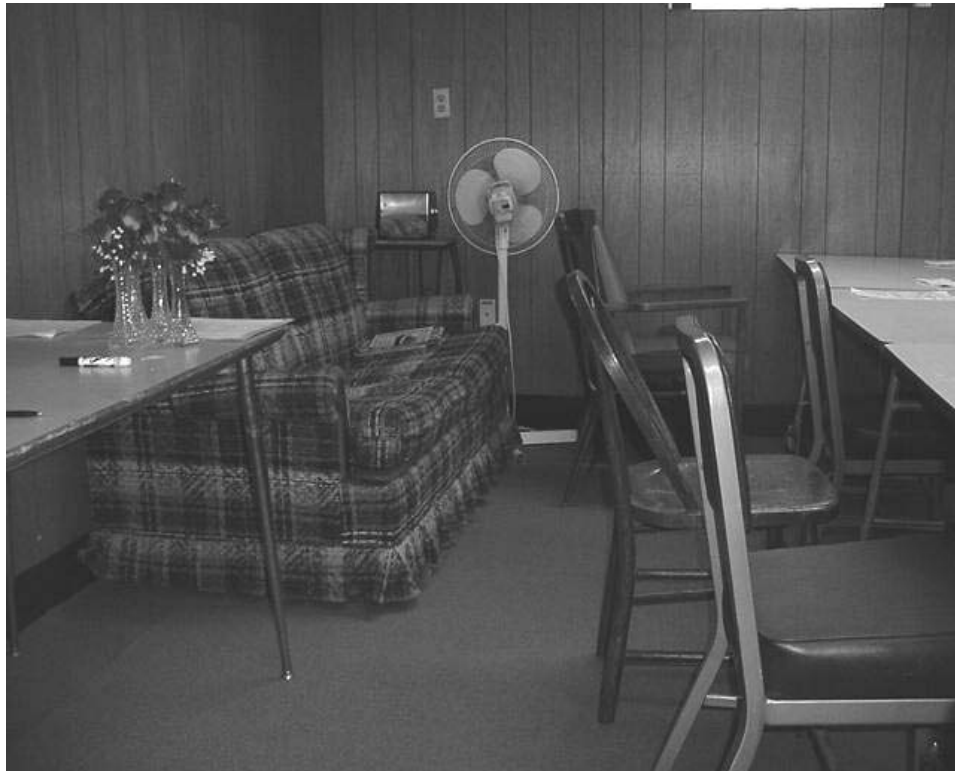
Picture 7

Potential sources of microbial growth and associated odors were also observed. Musty, mold-like odors were detected in the teacher's room. The teacher's room has wall paneling installed along exterior foundation walls (see Picture 7). In general, wall paneling installed in this manner may conceal and contain moisture from water penetration through the foundation wall through the exterior wall/tarmac junction or condensation on the cement. In either case, the paneling can serve to prevent the evaporation of moisture and can result in repeated moistening of wall paneling and wall-to-wall carpeting. Wall materials, such as paneling, can serve as a mold growth medium.

Wall Paneling in Teacher's Room in Basement

- 6) Remove and replace any mold contaminated/water damaged wall paneling, insulation, carpeting and ceiling tiles in the teacher's room. This measure will remove actively growing mold colonies that may be present. Remove mold contaminated materials in a manner consistent with recommendations found in "Mold Remediation in Schools and Commercial Buildings" published by the US Environmental Protection Agency, Office of Air and Radiation, Indoor Environments Division, Washington, DC. EPA 402-K-01-001. March 2001. Copies of this document can be downloaded from the US EPA website at:
http://www.epa.gov/iaq/molds/mold_remediation.html

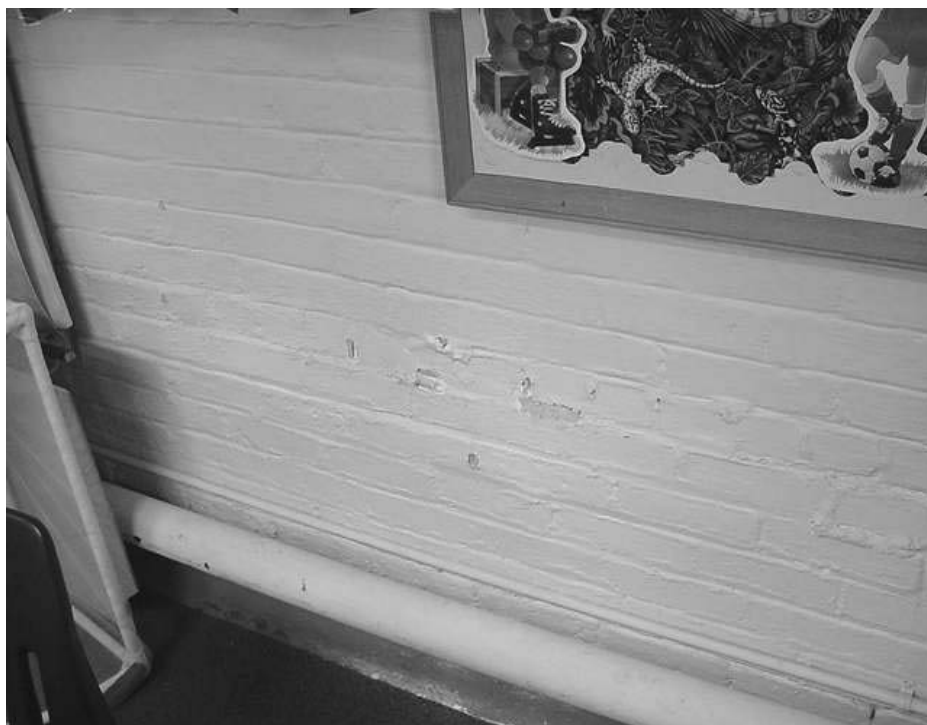
Picture 8

In addition, signs of water penetration through foundation walls were evidenced by the presence of peeling paint and efflorescence along exterior walls in areas with exposed, painted foundation wall brick (see Picture 8). Efflorescence is a characteristic sign of water damage to brick and mortar, but it is not mold growth. As moisture penetrates and works its way through mortar around brick, water-soluble compounds in bricks and mortar dissolve, creating a solution. As the solution moves to the surface of the brick or mortar, the water evaporates, leaving behind

white, powdery mineral deposits. A coat of paint can serve as a water impermeable barrier, which can collect moisture and efflorescence. Brick, mortar and wall plaster are not good mold growth media, however water trapped behind paint can serve that purpose.

Peeling Paint in Below Grade Classroom

- 7) To prevent moisture penetration into the basement, the following actions should be considered:
 - a) Remove foliage to no less than five feet from the foundation.

- b) Improve the grading of the ground away from the foundation at a rate of 6 inches per every 10 feet (Lstiburek, J. & Brennan, T.; 2001).
 - c) Install a water impermeable layer on ground surface (clay cap) to prevent water saturation of ground near foundation (Lstiburek & Brennan, 2001).

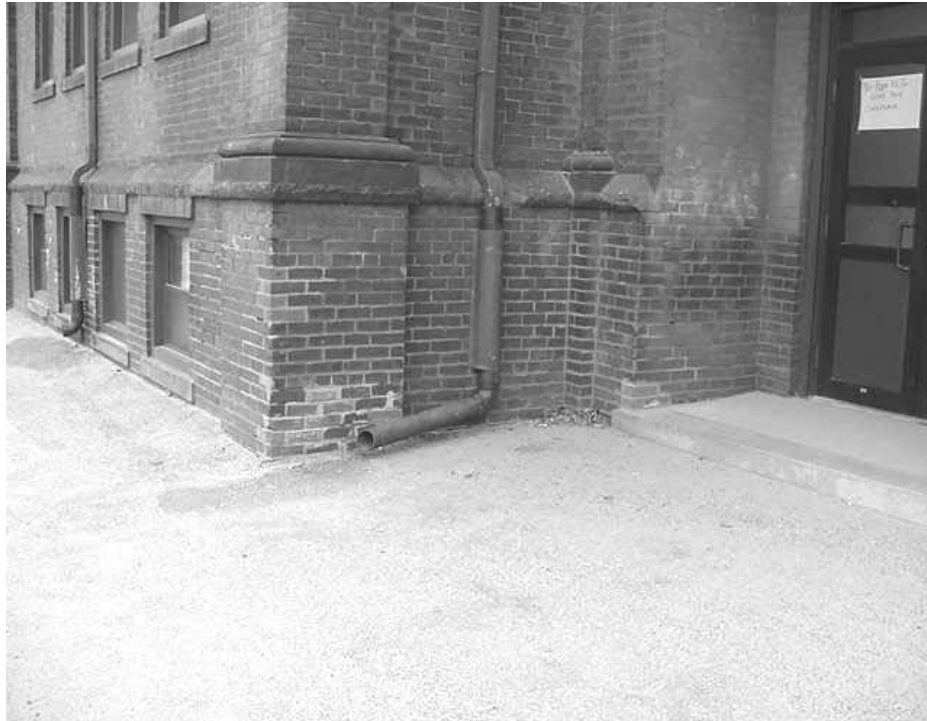
Different means for water to have prolonged contact with the foundation wall exist around the perimeter of the building. Small trees and other plants were seen growing in the tarmac/exterior wall junctions. In addition, downspouts for the building empty near the foundation (see Picture 9). The growth of roots against the exterior of foundation walls, as well as spaces between the tarmac, can bring moisture in contact with brick and foundation structures, which may eventually lead to moisture penetration below ground level areas of the building. Over time, this process can undermine the integrity of the building envelope and provide a means of water entry into the building via capillary action through foundation concrete and masonry (Lstiburek & Brennan, 2001).

Downspout Outside Of Classroom with Peeling Paint in Picture 9

- 8) Seal the exterior wall/tarmac seal to prevent water penetration.

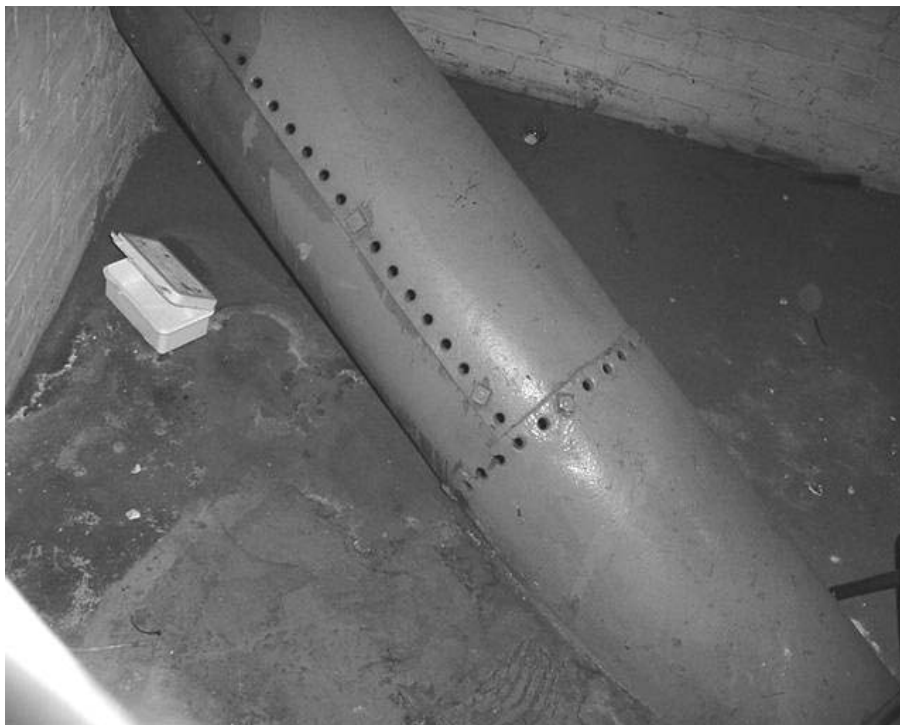
Picture 10

Several other conditions were noted during the assessment, which can affect indoor air quality. Of note was the existence of a large pipe that served as a coal chute in one of the air mixing rooms in the basement (see Picture 10). A number of holes were seen in the chute, which can allow air to move from the chute interior into the air mixing room. The coal chute appears to enter the boiler room. As previously noted, the original fresh air supply vents in some

classrooms are connected by airshafts to openings above the heating elements in this room. Under certain circumstances, odors and particulates from the boiler room can use the coal chute as a pathway to migrate into the air mixing room, which can travel into classrooms via the abandoned fresh air supply shafts. Several former pipe penetrations through a boiler room wall appear to penetrate into the air mixing room in the center of the building as well (see Picture 11). Other pathways exist for indoor pollutants to migrate from one area to another. Utility holes in basement interior walls (see Pictures 12 and 13) were observed. All of these breaches can serve as pathways for odors, drafts and particulates to migrate between rooms and floors.

The Coal Chute, Note Holes

- 3) Seal the holes in the coal chute.
- 4) Seal all openings in former air handling rooms.
- 5) Seal all holes and abandoned pipes in the walls of the boiler room.

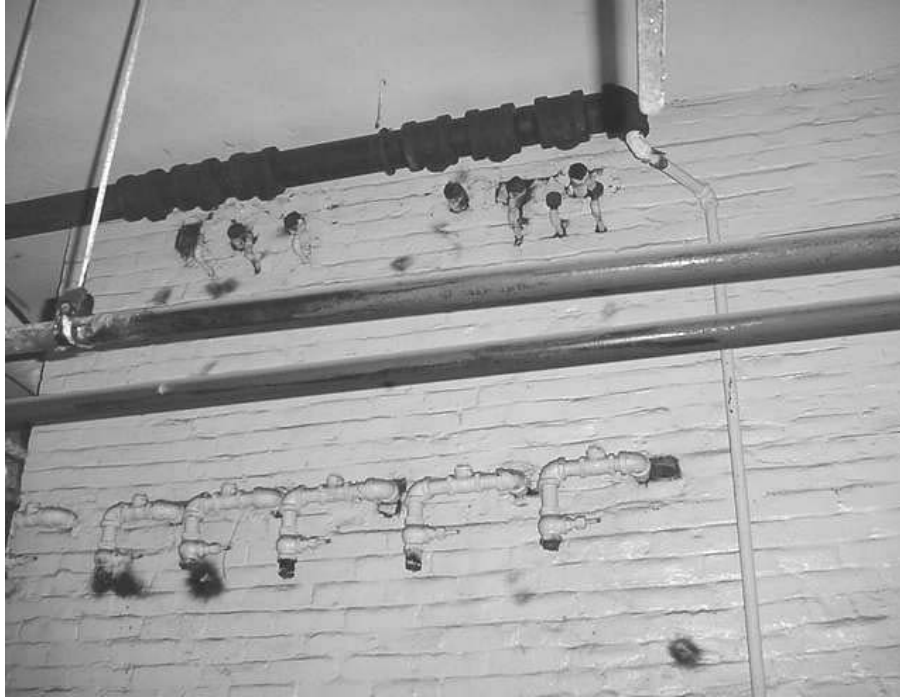
Picture 11

Holes/Abandoned Pipes in Boiler Room Wall

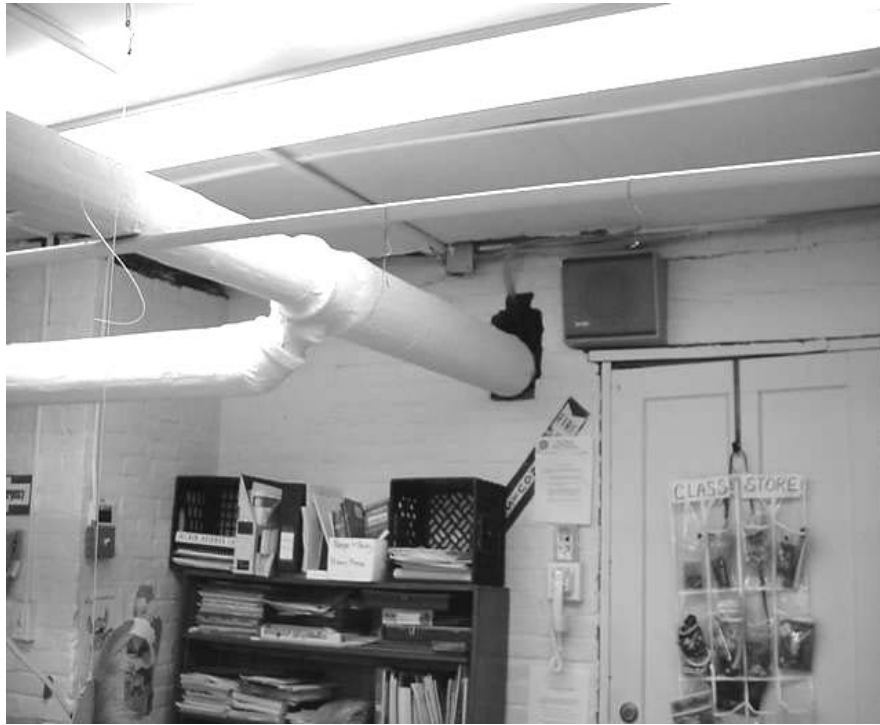
Picture 12

Hole in Basement Interior Wall

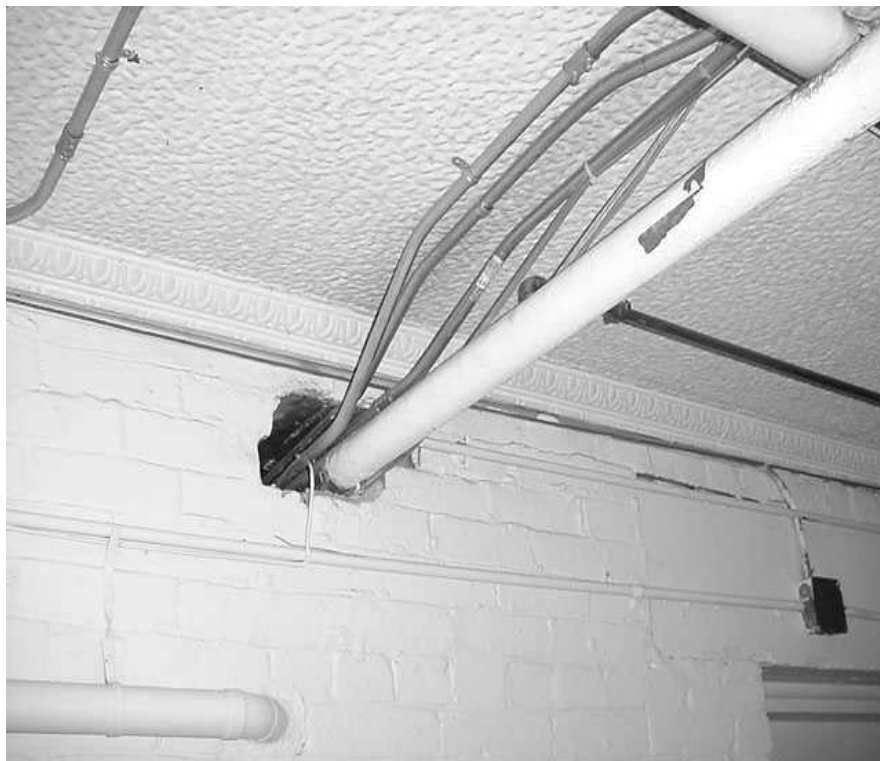
Picture 13

Hole in Basement Interior Wall

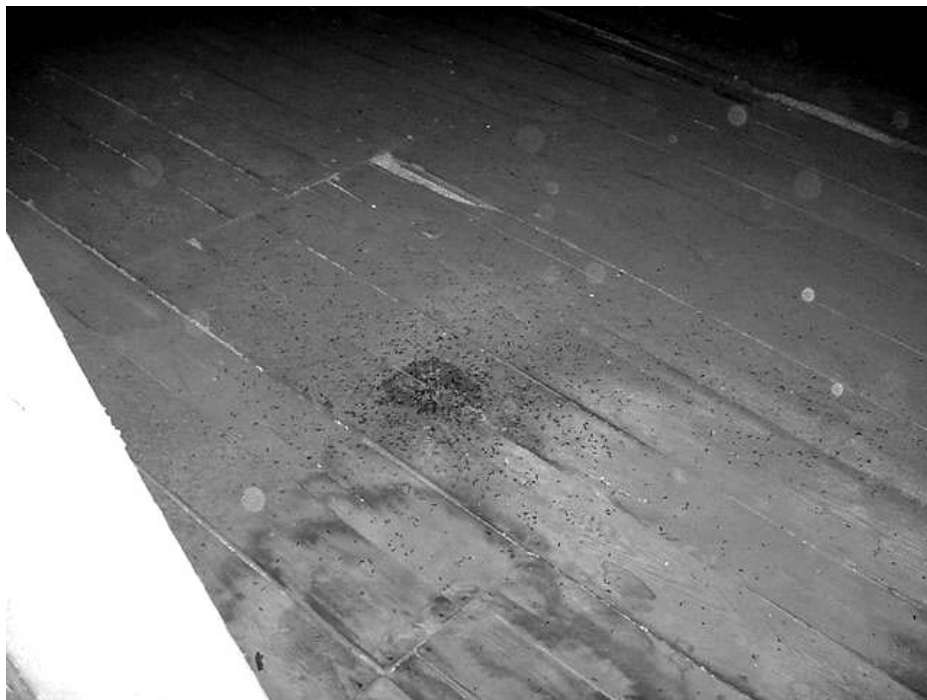
Picture 14

While in the attic, bat wastes were also observed (see Picture 14). Bats in a building raise concerns over diseases that may be caused by exposure to bat wastes. These conditions warrant clean up of bat waste and appropriate disinfection. Certain molds (*Histoplasma capsulatum*) are associated with bat waste (CDC, 2001; NIOSH, 1997) and are of concern for immune

compromised individuals. Diseases of the respiratory tract may also result from exposure to bat waste. While immune compromised individuals have an increased risk of health impacts following exposure to the materials in bat wastes, these impacts may also occur in healthy individuals exposed to these materials.

Bat Waste in Attic

The methods to be employed in clean up of a bat waste problem depends on the amount of waste and the types of materials contaminated. The MDPH has been involved in several indoor air investigations where animal waste has accumulated within ventilation ductwork. Accumulation of bat wastes have required clean up of such buildings by a professional cleaning contractor. In less severe cases, the cleaning of the contaminated material with a solution of sodium hypochlorite has been an effective disinfectant (CDC, 1998). Disinfection of non-porous materials can be readily accomplished with this material. Porous materials contaminated with bat waste should be examined by a professional restoration contractor to determine if the material is salvageable. Where a porous material has been colonized with mold, it is recommended that the material be discarded (ACGIH, 1989).

- 12) Clean dry erase board trays regularly to avoid the build-up of particulates.
- 13) Remove bats from attic/roof structures. Install a roof cap on chimney to prevent bat entry.
